# HISTORIC AMERICAN ROOF TRUSSES

## *III. Kingpost Trusses*

# Kingpost Truss Engineering, An Addendum

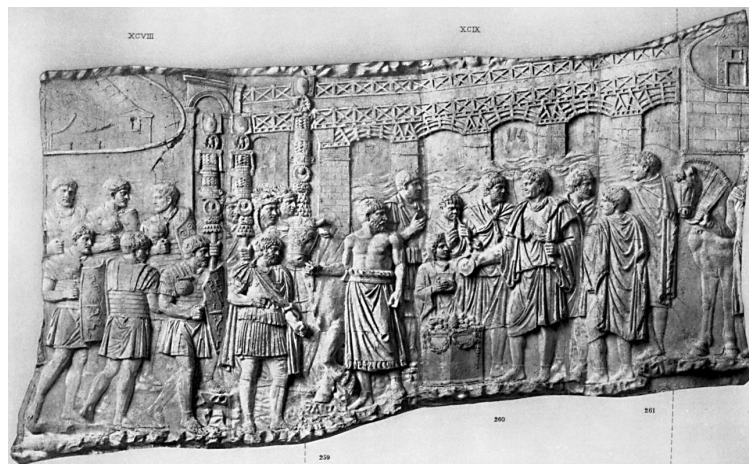
*Panel from Trajan's column depicting Apollodorus's bridge (ca. 105) across the Danube. Trussed segmental arches spring from triangulated supports to carry the bridge deck. Triangulated railings may help.*

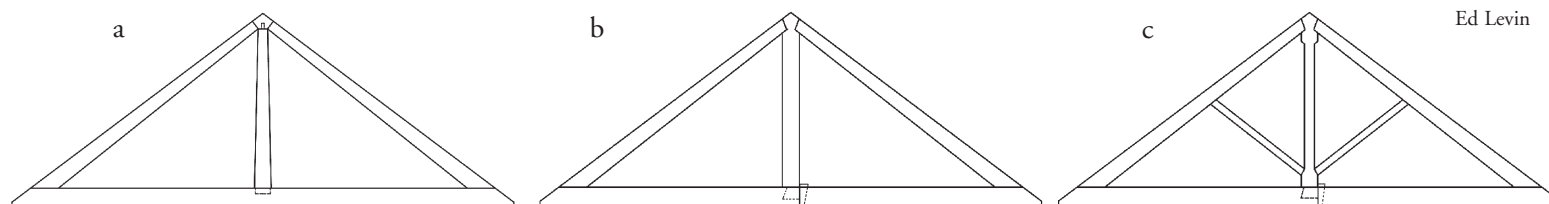
FIG. 1. HYPOTHETICAL DEVELOPMENT OF KINGPOST TRUSS: (A) CROWNPOST SUPPORTING RIDGE, (B) HUNG KINGPOST, (C) STRUTTED RAFTERS.

Outward pressure on the walls can be eliminated entirely by affixing the feet of each rafter couple to their own tie beam. The problem of sag can then be addressed by hanging a joggled vertical member, or kingpost, from these rafters and using it in tension to support the midspan of the tie beam. (Fig. 1b). By a less obvious intuitive leap, it might be realized that the midspan of the long rafters can be kept from bending by struts rising from lower joggles on the suspended kingpost (Fig. 1c).

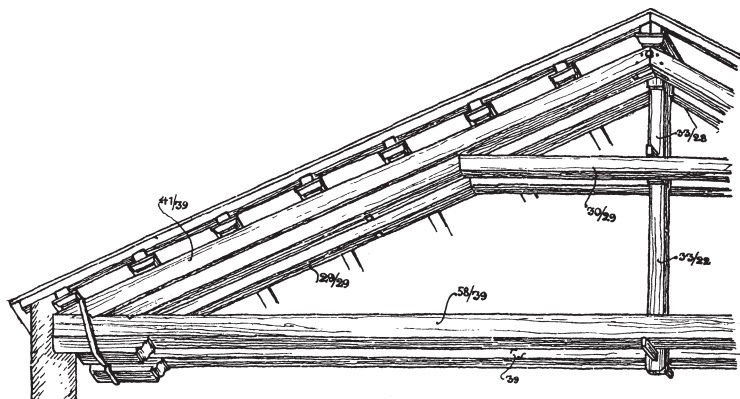
FIG. 2. OSTENDORF'S DRAWING AFTER RONDELET'S OF THE KINGPOST TRUSS OF ST. PAUL'S OUTSIDE THE WALLS, BEGUN CA. 384-86, REPAIRED IN THE 9TH CENTURY AND DESTROYED BY FIRE IN 1823.

Ancient roof systems that survived into the 19th century, such as the 78-ft.-span kingpost trusses at St. Paul's Outside the Walls, in Rome, represented three different periods of construction between the 4th and 15th centuries, and extensive repairs (Fig. 2 facing page). However, at least two observers (Gwilt 1867 and Rondelet 1881), while dating the trusses differently, agree that the kingpost was suspended and had tension joinery at its intersection with the tie beam.

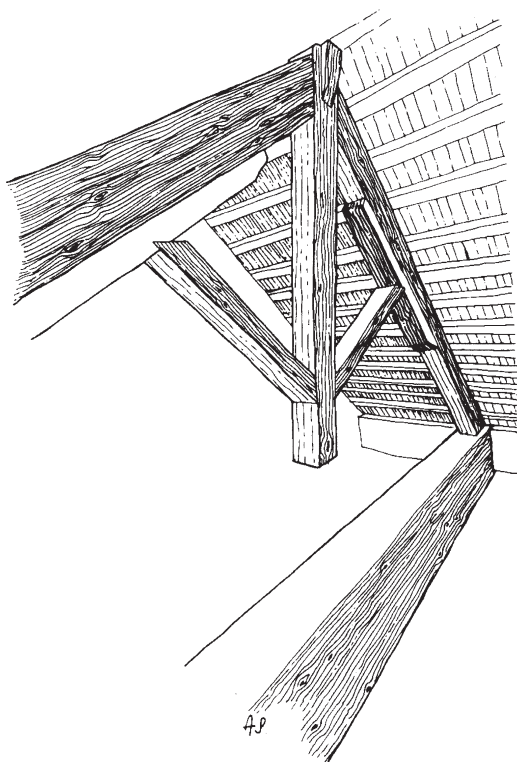
FIG. 3. KINGPOST TRUSS INSIDE THE NAVE OF THE 6TH-CENTURY MONASTERY ST. CATHERINE'S AT MOUNT SINAI IN EGYPT.

The mid-6th-century roof truss at the Monastery of St. Catherine at Mount Sinai, Egypt, is our oldest securely dated extant example. It is a kingpost variation known in England as kingpendant, i.e., the pendant kingpost doesn't reach or suspend the tie beam, in this case because the roughly 20-ft. span doesn't require midspan support (Fig. 3).

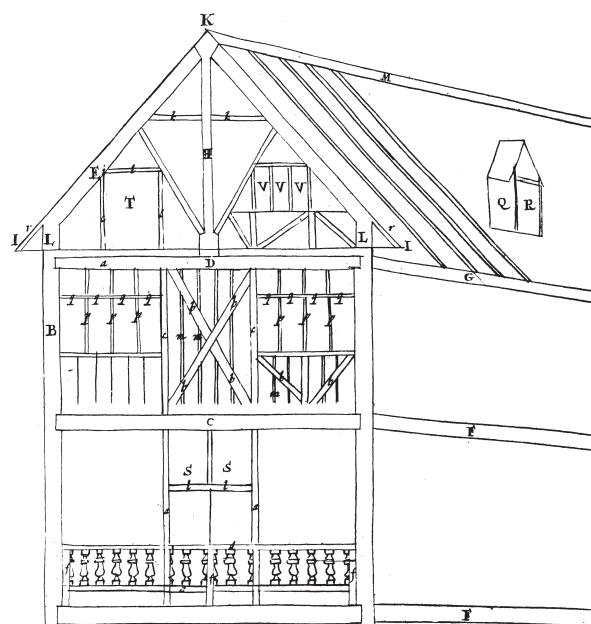
FIG. 4. MOXON'S DRAWING OF A KINGPOST TRUSS, 1687, DETAIL. POSITION OF TRUSS OVER FULLY STUDDED GABLE WALL MAY ALLOW PRESENTING NORMALLY DISPARATE ELEMENTS IN ONE DRAWING.

By the 16th century, illustrations of trusses and more-or-less modern discussions of their behavior were available in numerous Italian publications and, by the early 17th century, such trusses were being built and written about in England as well. In Italy, the truss was called *trabo reticulari* or "beam in the form of a net," not unlike some modern engineers' descriptions of trusses as having chords and a web (Yeomans 1992). In 1678, Moxon's *Mechanick Exercises* illustrates a fully developed kingpost truss with a flared head and struts rising from joggles on the kingpost to the midpoint of the rafters—but, inexplicably, over a fully studded gable wall in an otherwise common rafter roof (Fig. 4).

Moxon does use the word truss and refers the reader to sections on kingpiece or joggle piece for explication. (For the English etymology of the word *truss*, see the first article in this series in TF 69.) The 1681 Old Ship Meetinghouse in Hingham, Massachusetts, employs the oldest extant American example of a kingpost truss, although in a roof system of unusual form. Kingpost truss roof systems (and other truss form systems in lesser numbers) were built sporadically during the first half of the 18th century, but then by the tens of thousands during the later 18th and throughout the 19th centuries, by vernacular carpenters framing meetinghouses, churches, public buildings and bridges all over eastern North America.

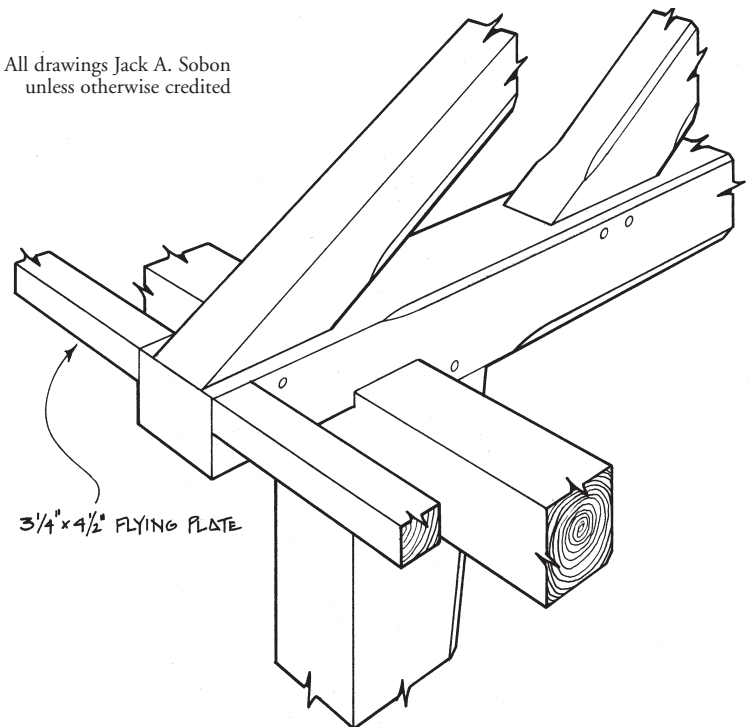
FIG. 6. RAFTER, TIE AND PLATE JOINTS, LYNNFIELD MEETINGHOUSE, AN ENGLISH TYING JOINT WITH OUTSHOT PLATE.

**Lynnfield Meetinghouse, Lynnfield Center, Mass., 1714.** The frame at Lynnfield originally measured 32 ft. 4 in. wide and 38 ft. long. Jowled wall posts, exposed to the interior, supported two kingpost trusses, framed entirely of oak. These trusses used naturally curved inner principal rafters to trap and support a gently tapering kingpost with a wedged, blind half-dovetail joint at its foot supporting the midspan of the tie. Outer principal rafters rising from the cantilevered ends of the 35-ft. tie beams tenoned into the slightly flared head of the kingpost and were supported at their midspan by short struts rising from the arching inner rafters. Large curved braces rose from elongated mortises on the flared posts to long, three-pin mortises on the ties, to help support the inner rafters where they bore on the tie beam inboard of the post (Figs. 5, 6).

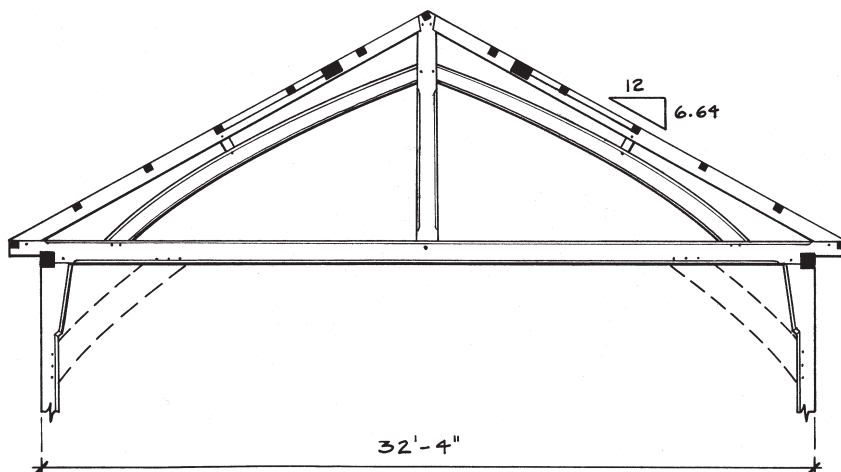
FIG. 5. LYNNFIELD (MASS.) MEETINGHOUSE ORIGINAL TRUSS, 1714.

The Lynnfield truss model performed well under load. Given mitigating factors like the modest span (32 ft., 4 in.), the stout material (oak) and the lack of a ceiling load, this does not come as a surprise. Predicted deflections remain within allowable ranges. Likewise bending stress, with the exception of the main braces at midspan where they share roof load with the rafters via connecting struts (which carry 6900 lbs. in compression). Here the deeper, stiffer braces take the lion's share of the load, supporting—and minimizing bending in—the rafter above at the cost of a 1650 psi spike in bending stress in the braces. Axial load distribution is ideal, with the major elements handling the bulk of the force (16,600 lbs. tension in the tie beam, 18,000 lbs. compression in the main braces). Tension at the kingpost foot is a mere 4100 lbs. Given the minimal force in the rafters near the peak, above the main brace junction the kingpost goes into compression, signifying the absence of uplift at the peak.

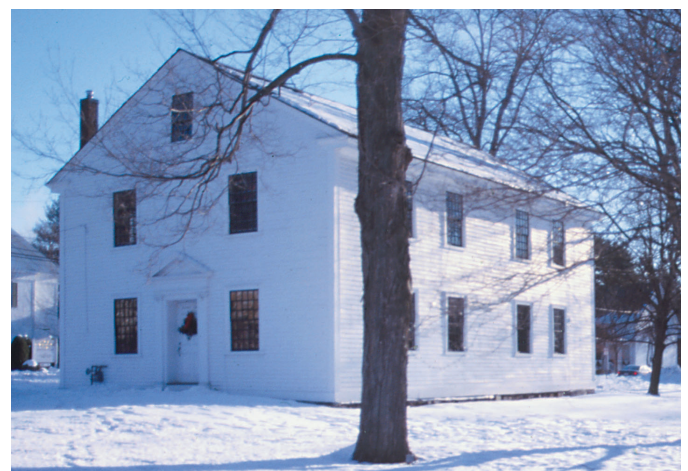
*Lynnfield exterior is austere and without tower.*

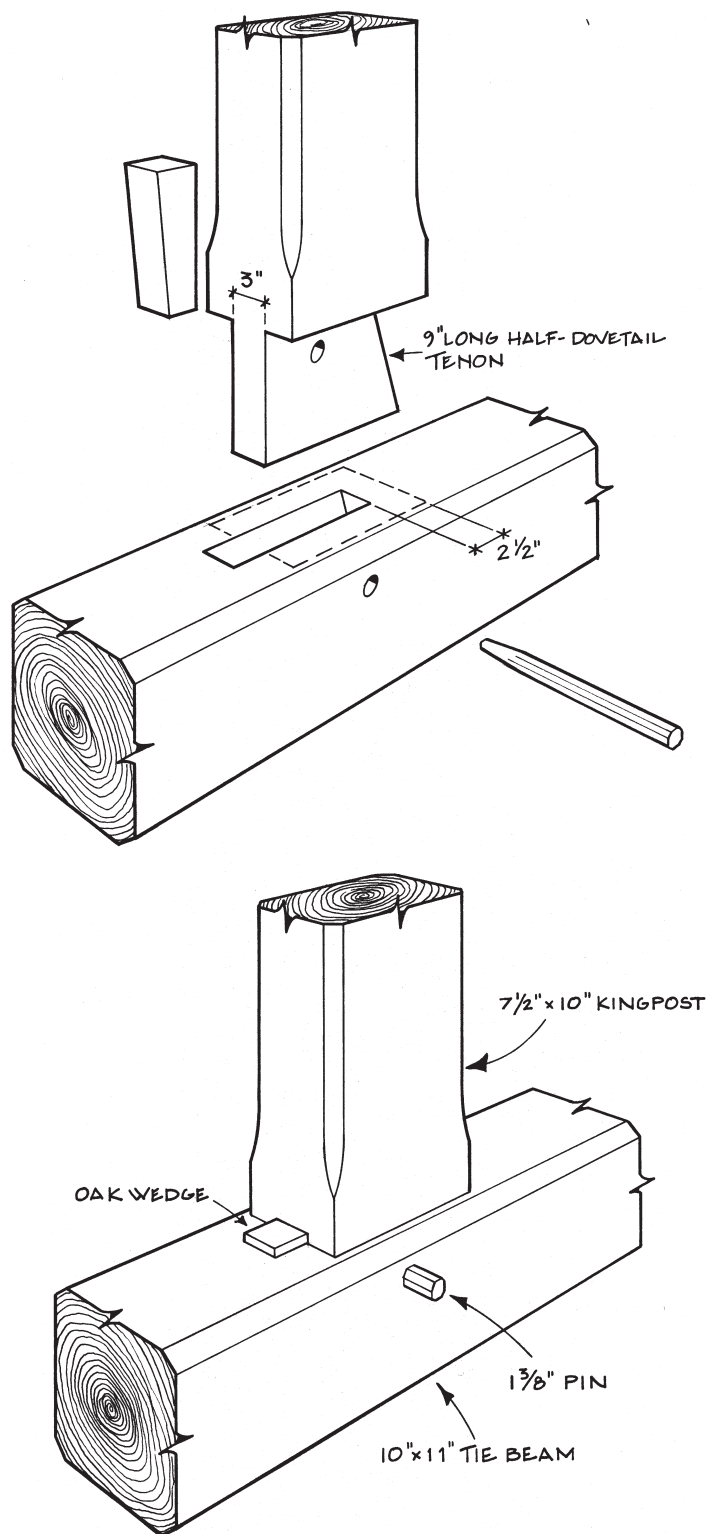
FIG. 7. KINGPOST-TO-TIE JOINT, ASSEMBLED AND EXPLODED VIEWS, LYNNFIELD MEETINGHOUSE. ORIGINAL TRUSSES ARE ENTIRELY OAK; LATER ONES USE PINE RAFTERS AND TIE BEAM.

curved, but there was no provision for large curved bracing rising from the wall posts to support them. On the old trusses the wedged half-dovetail at the kingpost-to-tie joint is not in a through mortise, the dovetail has 2 1/2 inches of slope, and it is transfixed by a single 1 3/8-in. pin (Fig. 7). On the new trusses the kingpost is not as wide, 8 1/2 in. as opposed to the 10 in. of 1714; the mortise passes through the 10x11 tie beam, the slope of the dovetail is only 1 1/2 inches and it is transfixed by a single 7/8-in. pin. The old trusses are performing better at this joint than the new ones; the explanation may be the crushing of end grain in the mortise in the pine tie, the reduced slope on the dovetail tenon or the relatively small pin—solely or in combination.

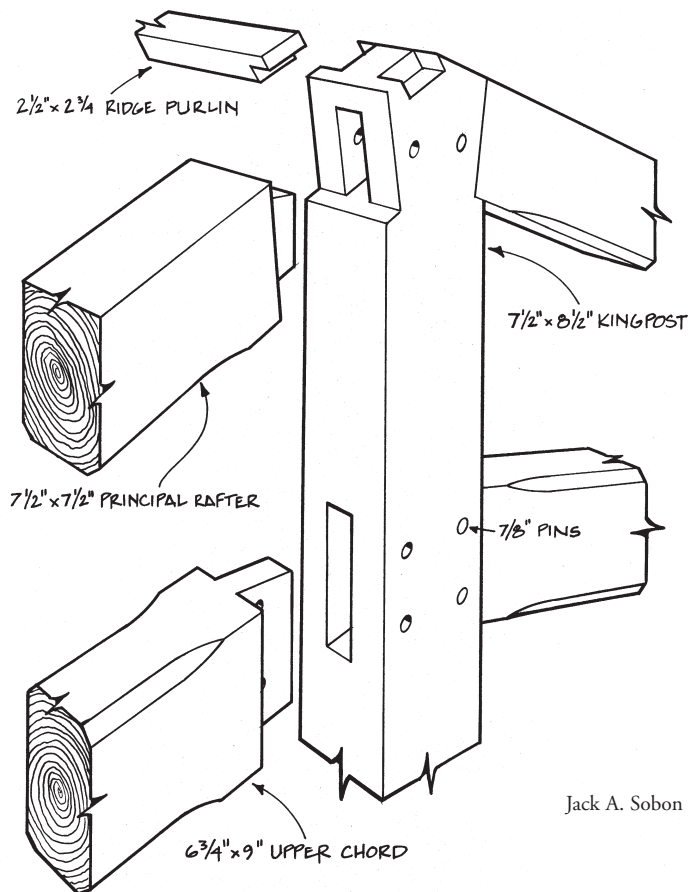
FIG. 8. EXPLODED VIEW OF PEAK JOINT, LYNNFIELD MEETINGHOUSE. UPPER TRUSS CHORDS ARE INDEPENDENT OF ROOF RAFTERS.

The new trusses, unlike the old, also have no flared abutments or joggles at the kingpost head (Fig. 8); but if there is anything surprising that our examination of a great many historic trusses has shown, it is that normal bearing or the lack of it at chord-to-kingpost connections results in no truss deformation. The 1801 Windham Congregational Church in Windham, Vermont, with its very heavily built kingpost trusses of 45-ft. span, is just one more example of many whose rafters, both inner and outer, engage the kingpost with no cut joggle of any sort, instead using a 2- or 3-in. tenon with shoulders cut at the roof angle (Fig. 10 below). It may be that the kingpost-to-tie joint is always weaker and that failure will occur there rather than at the head. It may be also that the weight and nailed-together matrix of roof boarding and shingles keep the joint together at the very head of the post.

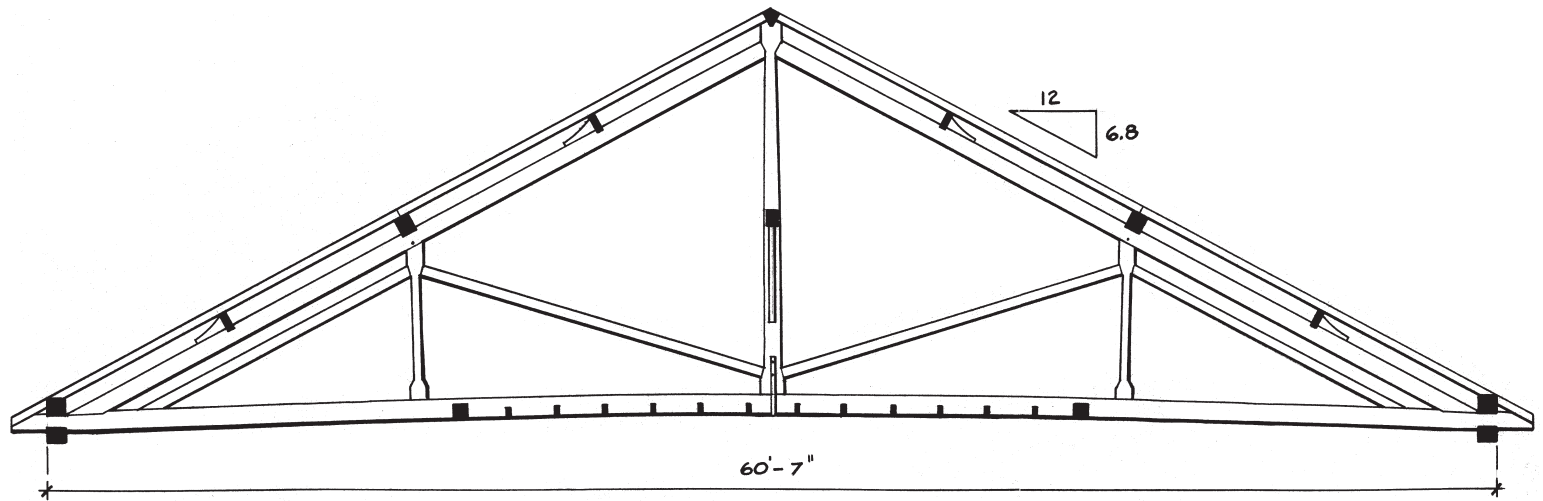
FIG. 9. CASTLETON FEDERATED CHURCH, 1833. LONG-SPAN KINGPOST TRUSSES ARE CONSIDERABLY STRENGTHENED BY PRINCEPOSTS IN TENSION.

**Castleton Federated Church, Castleton, Vermont, 1833.** Castleton Federated is a large brick church with a timber roof system and a storied steeple that terminates 132 ft. above the ground. The roof is composed of kingpost trusses spaced 10 ft. apart, spanning 59 ft. 1 in. in the clear, with a single-stick 11x11 bottom chord length of 63 ft. 7 in. overall. The trusses are fitted with princeposts (sometimes called queenposts) that flank the kingpost and further divide the span. The chords are not the only long members in the building. The  $8\frac{1}{2} \times 9\frac{1}{2}$  purlins notched over the truss rafters directly above the princeposts are single timbers nearly 70 ft. long (Fig. 9). The pendant mast of the spire, originally a 51-ft. 9x9 chestnut timber, was replaced with an equal-sized stick of pignut hickory in 1989 by the author.

The truss at Castleton has single principal rafters with three lines of purlins lodged atop the rafters, carrying a deck of 4x4 common rafters. One purlin is the aforementioned large timber above the princeposts, but the other two are lines of 3x9 interrupted timbers sitting against cleats at the approximate quarter points along the principal rafters. The princeposts, which have joggles top and bottom, are correctly supported by low-angled struts, one rising from the lower joggles on the kingpost and the other from a mortise in the bottom chord about 3 ft. inboard of the bearing walls, so that the princeposts suspend the bottom chord as well, rather than bearing upon it. The kingpost suspends the center of the bottom chord with a 2-in. through tenon assisted by an iron strap with 1-in. iron pins, while the princeposts use a mortise and tenon joint with two wooden pins and no ironwork.

The Castleton (Vt.) Federated Church (1833) moves us firmly into the classical kingpost idiom, with a truss spanning an ambitious 60 ft., 7 in. Nesting inside the major triangle are two minor trusses built around princeposts which, fractal-like, echo the parent truss. The central struts rising from the kingpost foot double as struts descending from the princepost peaks, each opposed by an outer strut paralleling the main upper chord (principal rafter).

The Castleton computer model predicts tension loads of 37,900 and 15,500 lbs. in tie and kingpost, 31,000, 17,800, 12,800 and 2700 lbs. compression in rafter, inner strut, outer strut and princeposts. The kingpost pulls tension throughout, carrying 4900 lbs. at the foot joint and 15,500 lbs. at the peak. The princeposts lift 2600 lbs. at their feet and carry a compression load of 8500 lbs. at their heads. Tying joint tension at the eaves is 26,500 lbs. Nothing alarming about these numbers, but there are multiple instances of bending stress up in the 1600 psi range, pretty high for Eastern hemlock, and a 1½-in.-plus sag in the rafters.

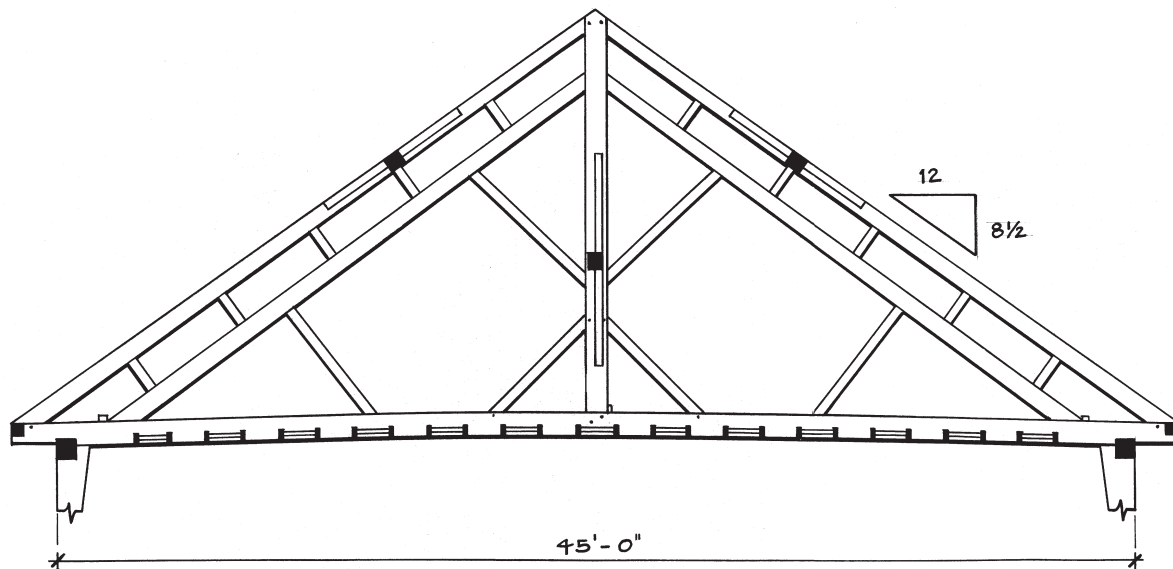
FIG. 10. WINDHAM, VERMONT, CONGREGATIONAL CHURCH, 1800. STRUTS AND UPPER CHORDS BEAR ON UNJOGGLED MORTISES.

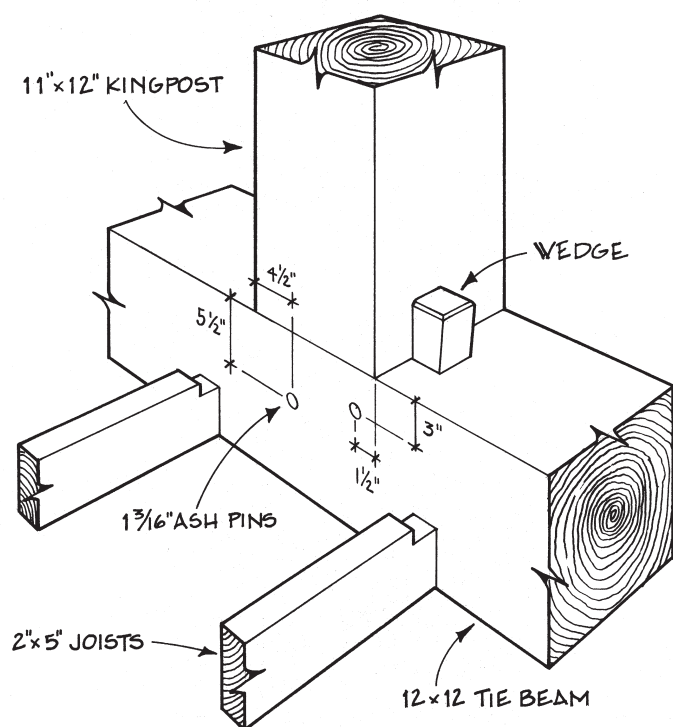
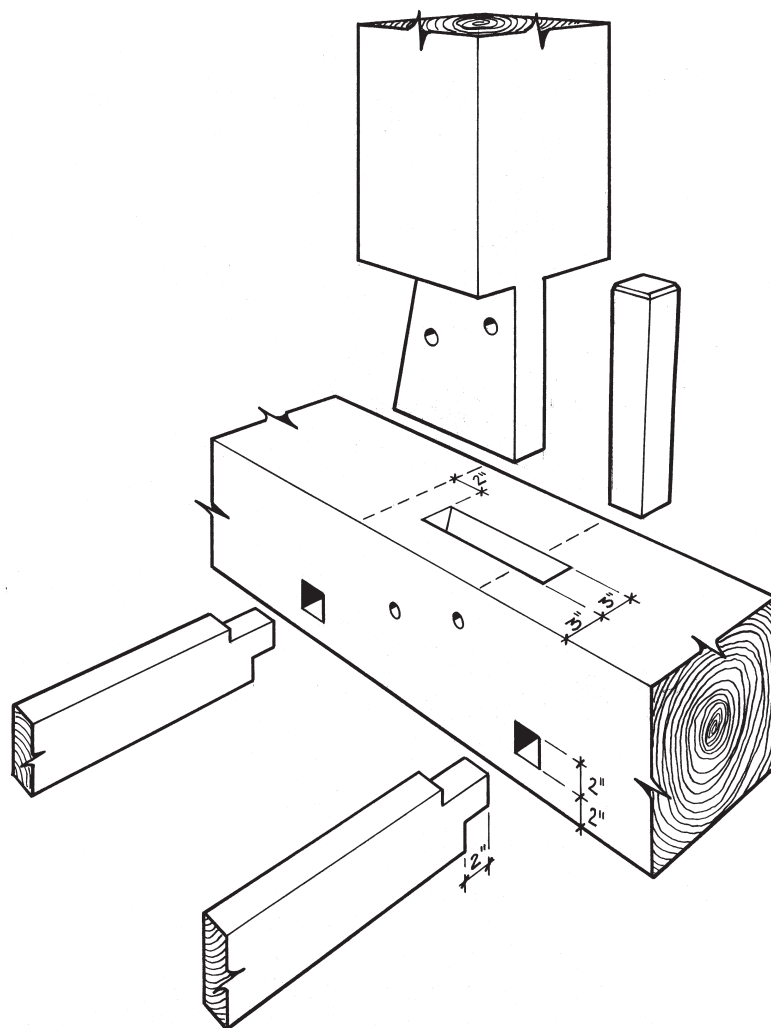
FIG. 11. KINGPOST-TO-TIE JOINT ASSEMBLED AND EXPLODED, WINDHAM CONGREGATIONAL CHURCH, 1800. JOISTS ARE INSERTED AT ONE END AND SWUNG INTO PLACE AT OPPOSITE END VIA PULLEY MORTISES, SEEN IN TRUSS ELEVATION ABOVE.

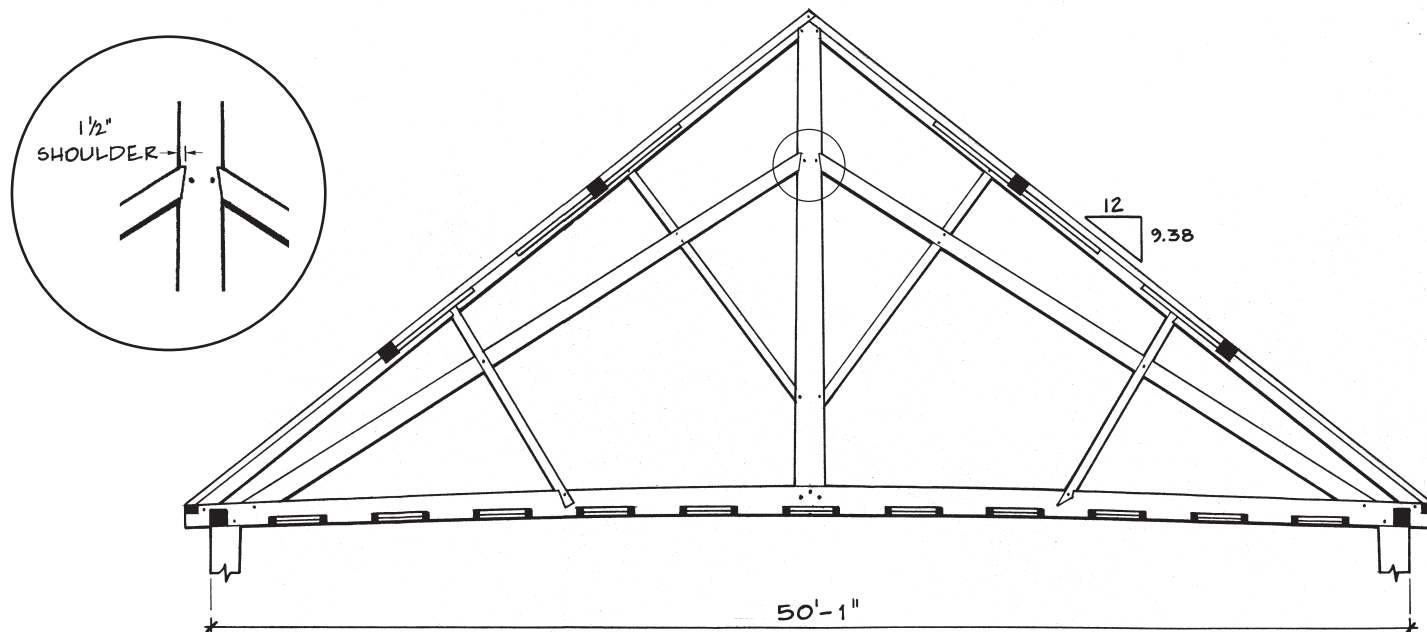
FIG. 12. STRAFFORD, VERMONT, MEETINGHOUSE, 1799, WITH DETAIL OF UPPER CHORD ABUTMENTS.

**Strafford Meetinghouse, Strafford, Vermont, 1799.** Strafford is a late example of an older style of New England meetinghouse, with a plain exterior little influenced by classicism and a steeple rising from the ground at one gable wall rather than engaged with the body of the building atop a portico, as was already stylish at the time. The roof is steep, pitched  $9\frac{1}{2}$  over 12, and its trusses, framed by the scribe rule, are monumental and complex: the span is 50 ft. 1 in. and the height of the kingposts themselves 22 ft. Bay spacing is slightly irregular within several inches at around 12 ft., with no two (of five) bays identical. The hewn bottom chords, principal rafters, kingposts and plates are spruce, while the vertically sawn braces, struts, joists, common rafters, purlins and flying plates are hardwood: a mixture of beech, yellow birch and maple (Fig. 12).

The 12x14 bottom chords show, variously, 5 to 7 inches of camber. An 11x14 kingpost rises from a three-pinned through tenon at the bottom chord to measure 10x11 at the peak. The inner rafters taper from  $7\frac{1}{2}$ x10 at the bottom to 7x7 at the top, and tenon into the kingpost with  $1\frac{1}{2}$ -in. bearing shoulders, indicating that these members were intended to be the top chords of the truss (Fig. 12 detail). The outer rafters measure 9x10 at the bottom and again taper toward the top where they are tenoned and pinned, without flared shoulders and with very little relish, into the top of the kingpost. These outer rafters carry the two lines of 8x9 purlins, and consequently the 3x5 common rafters and the roof deck, the weight of which helps keep them in place. The inner rafters, providing main support for the kingpost, bear on the bottom chord right over the inner edge of the wall posts. The outer rafters bear at the very ends of the bottom chord with very little relish (Fig. 13). In four cases this short relish has failed in double shear, a result of the innate vulnerability of the joint and the unfortunate addition of slate roofing on a frame designed for wood shingles; these four joints are now restrained with steel bolts.

The Stafford (Vt.) Meetinghouse (1799) also evokes older carpentry traditions, with its distinctive strut layout and doubled, divergent upper chords, evocative of scissor trusses. Here long and large section timbers are spruce, the smaller, shorter pieces mixed beech, birch and maple. FEA output for the Stafford truss again shows deflection, shear and bending stress remaining in the fold save for local maximums in the tie beam where it cantilevers beyond the wall to support the flying plate and principal rafter foot. Given ample real world proportions (as opposed to the slender single line geometry of the model), this can be mostly written off as a computer artifact. Resultant axial forces break down as follows: 24,700 lbs. tension in the tie beam and kingpost, 13,400 and 18,200 lbs. compression in the main braces and principal rafters, 6400 and 7200 lbs. compression in outer and inner struts. Contrary to the builder's expectation as indicated by strut lap dovetail ends, the Stafford outer struts are loaded in compression rather than tension.

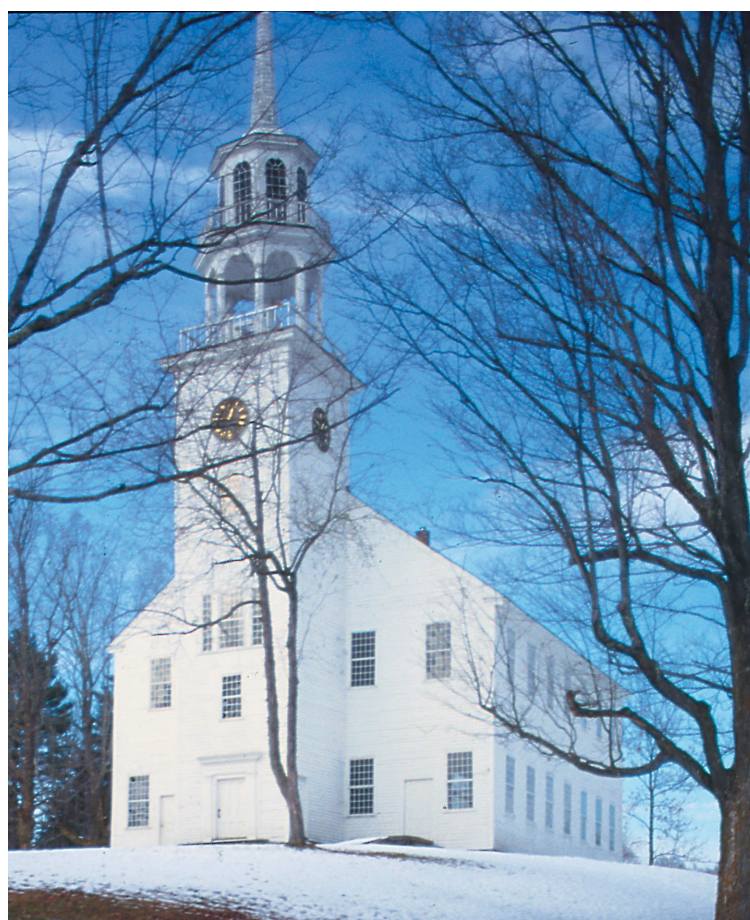
Ken Rower

*Strafford Meetinghouse, 1799, modest and chaste except for its proud octagonal steeple over a square clock tower.*

The inner and outer rafters are not parallel. The inner ones have a lower pitch and are thus shorter and potentially more resistant to buckling. However, this choice of inner rafters as the important top chord of the truss, unattached to horizontal purlins or the weight and diaphragm of the roof, leaves them vulnerable to buckling under load. The framers at Strafford tried to deal with this problem by adding supplemental struts and a raking strut to each side of the truss, but with only partial success. The supplemental struts are more or less typical, 4x4s rising from anunjoggled mortise in the post at a steep angle and tenoning into the inner rafters at

restrain the outer rafter from upward buckling or outward slippage (photo below). Crucial to understanding the framer's thought is the halving and tight trenching of the 4x4 where it crosses the inner rafter and is fastened as well by a 1½-in. pin. The joinery suggests the raking strut is to help the inner rafter resist buckling, adequate in an upward direction but a marginal construct against horizontal buckling. On the Strafford trusses, several inner rafters have buckled outward, away from their joints with this raking strut, or have bent or even broken the member when a rafter elected to buckle toward one already weakened by excessive slope of grain. The half-dovetails on the raking struts also have bearing shoulders that can work in compression to help the outer rafters bear the lower 8x9 purlins. That is what the raking struts seem to be doing at this point in the life of the trusses even though the purlin bearings are 2½ ft. away.

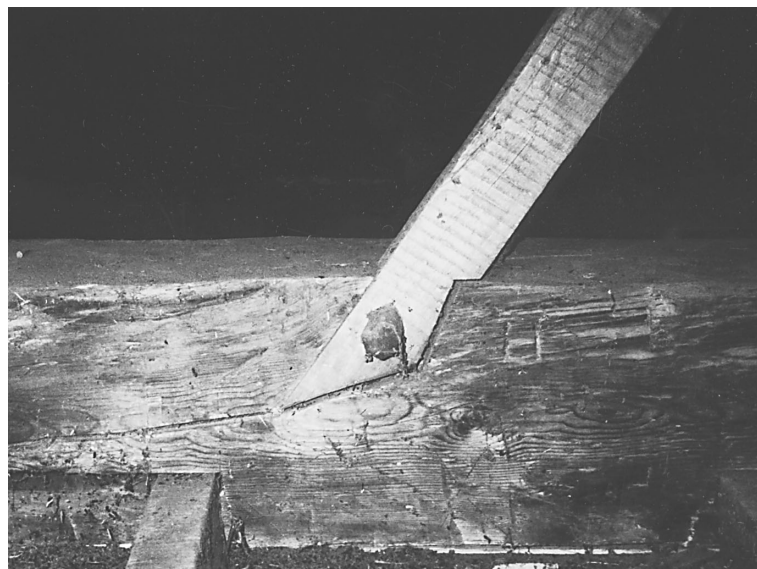
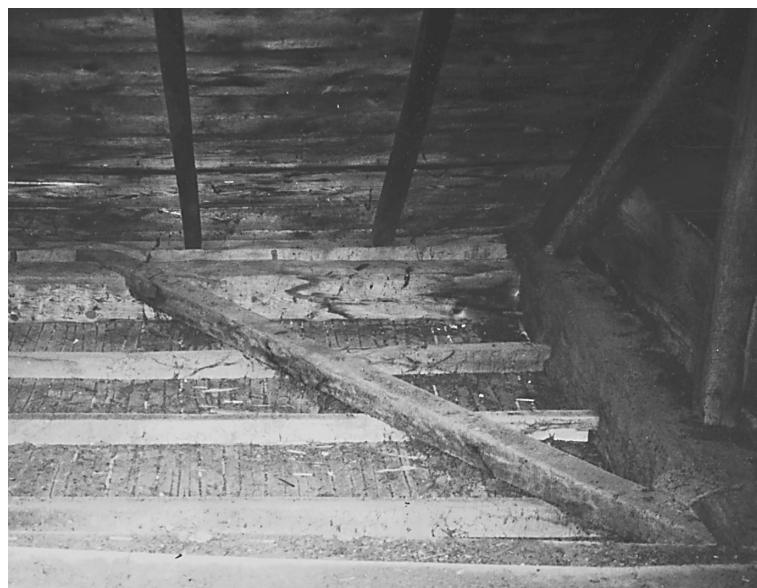
*At top, pinned dovetail lap at lower end of raking strut connecting tie beam with upper rafter at Strafford. Above, brace that helps support the interrupted flying plate spanning from tie beam to tie beam.*

In an unusual arrangement, the Strafford roof framing includes floor-level 4x7 horizontal braces that tenon into the sides of the tie beams, notch over the plates and tenon into the sides of the 4x6 flying plates to help support them near their midspan (photo below).

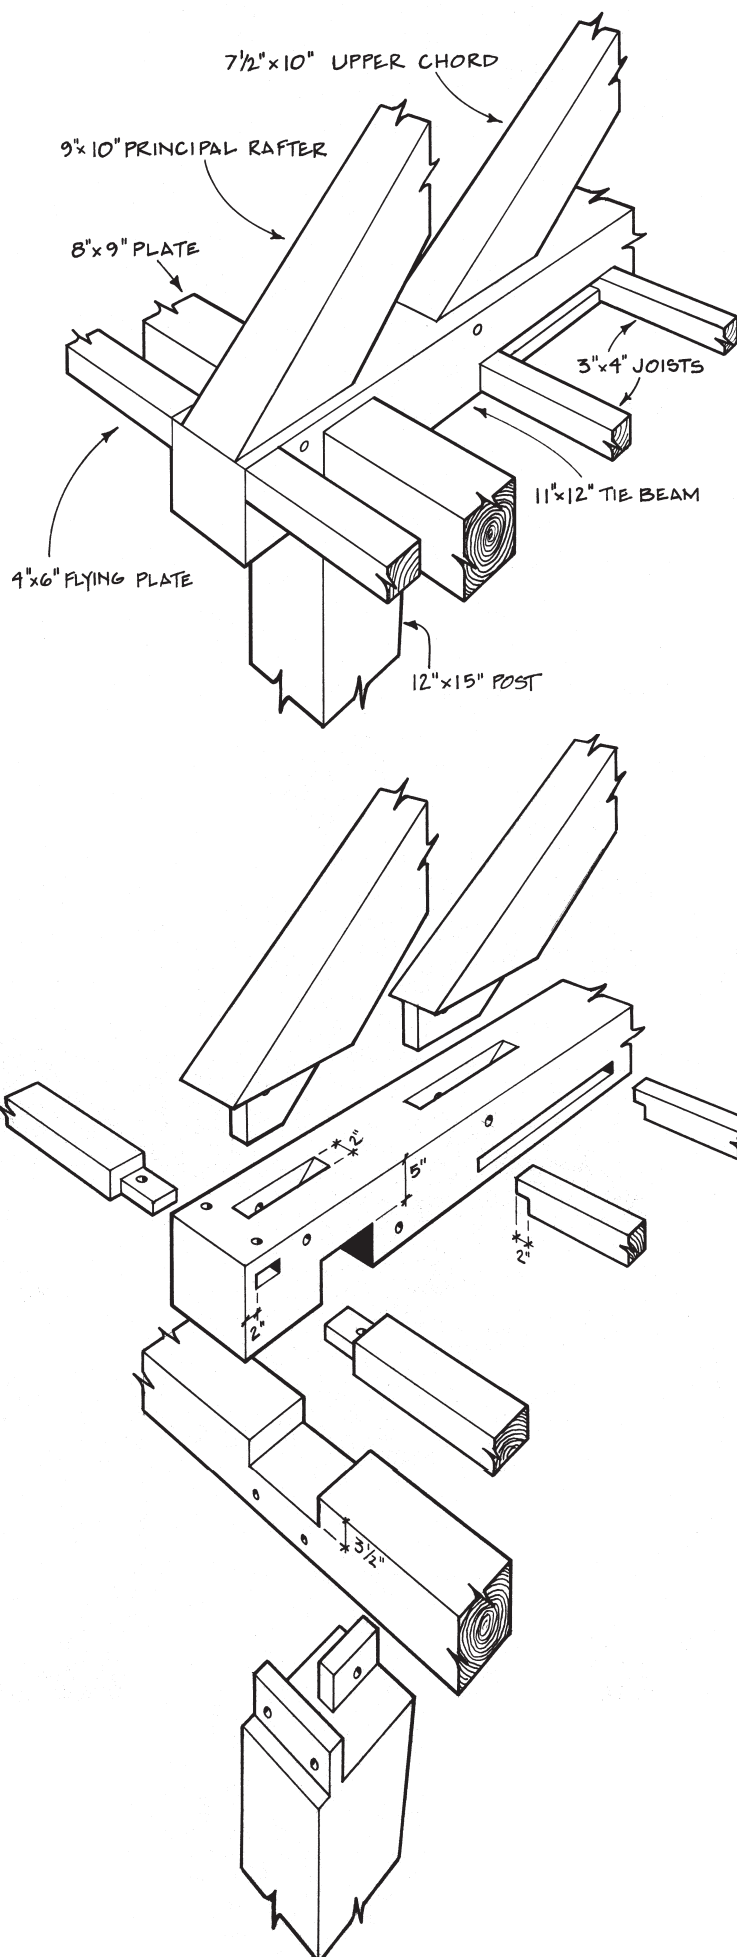
FIG. 13. STRAFFORD MEETINGHOUSE, ASSEMBLED AND EXPLODED VIEWS OF TYING JOINT WITH UPPER CHORD SEATS.

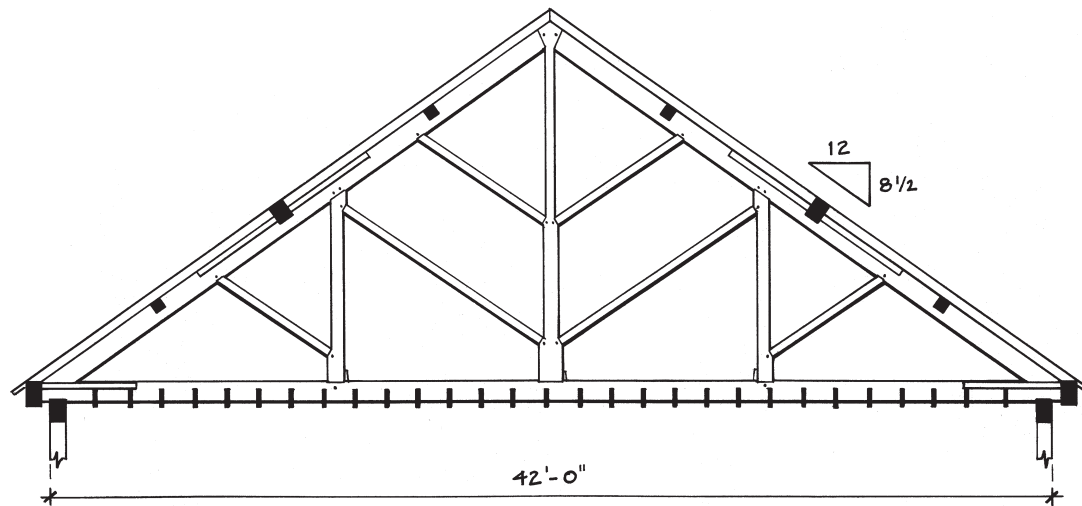
FIG. 14. UNION MEETINGHOUSE, 1870, APPARENTLY CLOSELY PATTERNED AFTER THE BUILDER'S GUIDE DRAWING BELOW.

**Union Meetinghouse, Huntington, Vermont, 1870.** The kingpost truss with princeposts at the Union Meetinghouse spans 41 ft. 8 in. in the clear with the bottom chord 44 ft. long overall (Fig. 14). This truss is an example of the persistence of good design; it is nearly identical to one shown on Plate 54 of Asher Benjamin's *Practical House Carpenter* (Benjamin 1839), which he describes (p. 78) as "very ancient, strong and simple . . . and the best constructed plan of any now in use" (Fig. 15). Union's unusual feature, which suggests direct copying from the pattern book, is the double-strutted kingpost, from which one pair of struts rises to the approximate upper quarter point of the rafter while a lower pair rises to brace the head of the princeposts (or queenposts in Benjamin's terminology). Each pair of struts rises from its own set of joggles on the kingpost, diminishing the kingpost twice until it is only 4½x8 before flaring to near-perpendicular bearing at the heads of the rafters.

Maybe it would have helped to adopt a truss pattern more like that of the 1870 Union Meetinghouse in Huntington, Vt., an almost exact copy of a pattern from Asher Benjamin's *Practical House Carpenter* (1830). The FEA model of the Union truss does not disappoint. Predicted deflections are minimal. Bending is modest save at the ends of the princeposts where impacted by strut loads, and even there, stress does not exceed allowable values. Axial loads are among the lowest we have seen: 22,200 and 14,100 lbs. tension in tie and kingpost, 27,800 lbs. rafter compression. Strut compression ranges from 4300 to 5800 lbs. Princeposts feel scant axial force at midspan, 2400-2500 lb. compression at their end joints. Adjacent princerods pull 2500 lbs. Tension at the kingpost foot joint is a mere 2000 lbs.

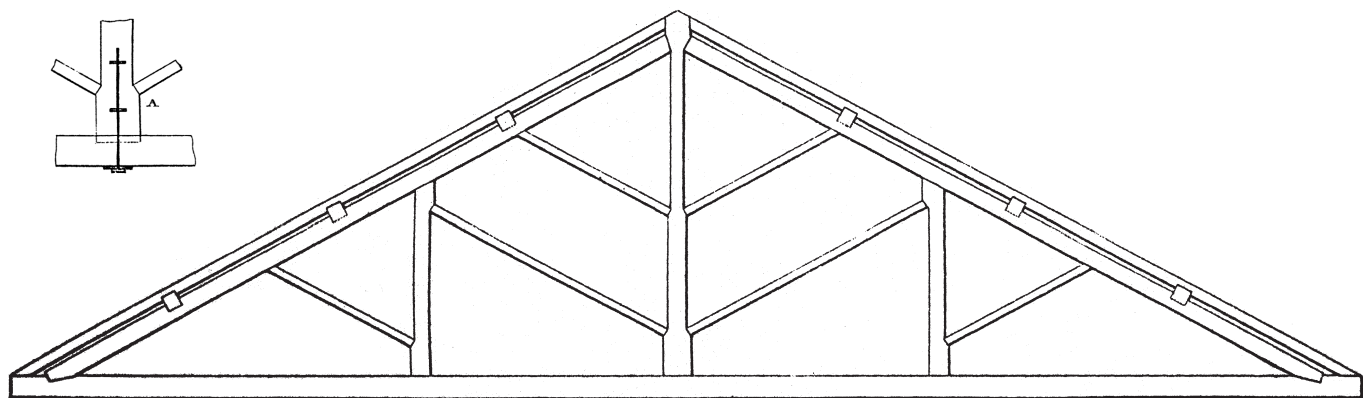
FIG. 15. ASHER BENJAMIN'S DRAWING OF A KINGPOST TRUSS WITH "QUEENPOSTS," PUBLISHED IN HIS *PRACTICAL HOUSE CARPENTER*, 1839. DETAIL SHOWS METHOD OF FASTENING POSTS WITH VERTICAL BOLTS THROUGH TIE BEAM TO CAPTIVE NUTS SUNKEN IN THE POSTS.

In spite of Benjamin's assertion that this truss is of ancient lineage, the double strutting from double joggles is rare in practice or in the literature surveyed. There are minor departures in joinery between Benjamin and the Huntington truss. Benjamin, in 1839, recommends using the then-modern center drilled bolt to join the kingpost with the bottom chord. In this system, a long hole is drilled up through the end grain of the post, arriving at a square chisel-cut hole where a nut will await the bolt that also passes through the bottom chord (Fig. 15 detail). The possibility of turning or restraining the upper nut is provided by grooves filed in the sides of the square nut that can be hit with a cold chisel. Further, at Huntington, both the king and princes have wedged half-dove-

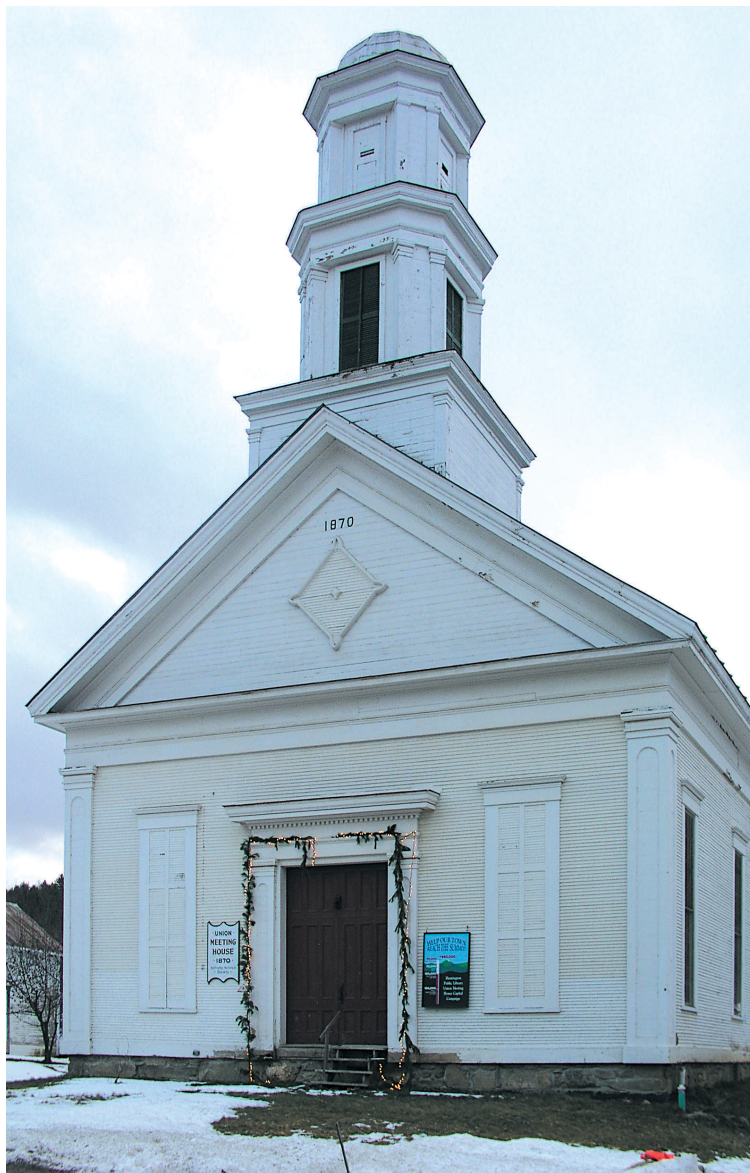
Photos Ken Rower

*Union Meetinghouse, Huntington, Vermont, 1870, finished in late neoclassical style, now converted to a public library.*

tails at their bottom chord joints and, in the case of the trusses helping to support the steeple, the princes are closely paralleled by 1-in. iron rods dropping from the rafters and passing through the bottom chord. The rods may be contemporary with the truss but could also have been installed during the next 50 years with no identifiable difference in their form or manufacture. In addition to the bolt, Benjamin's drawing also provides for a larger wooden shoulder at the principal rafter-to-tie point of bearing than that found in the Union Meetinghouse.

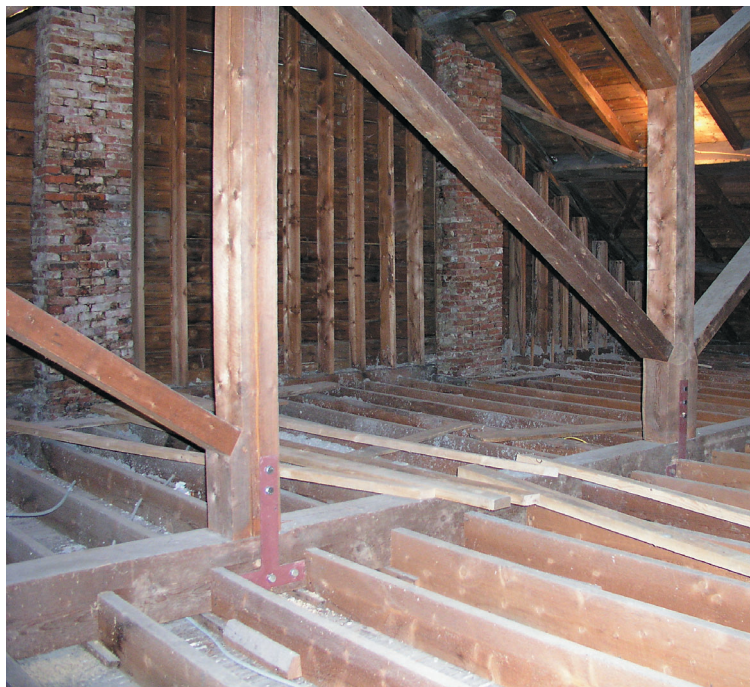
*Lower part of truss. Toe-nailed 2x8 joists pass under the tie beams to set lath 2 in. below ties. Long-serving tension joints have been reinforced.*

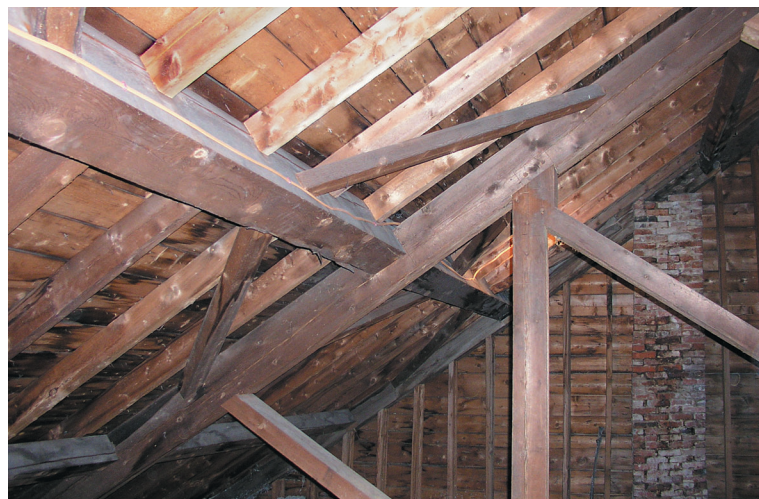
*Huntington, upper part of truss with strutted princepost. Wind-braced principal purlins overlap the upper chords and connect the trusses.*

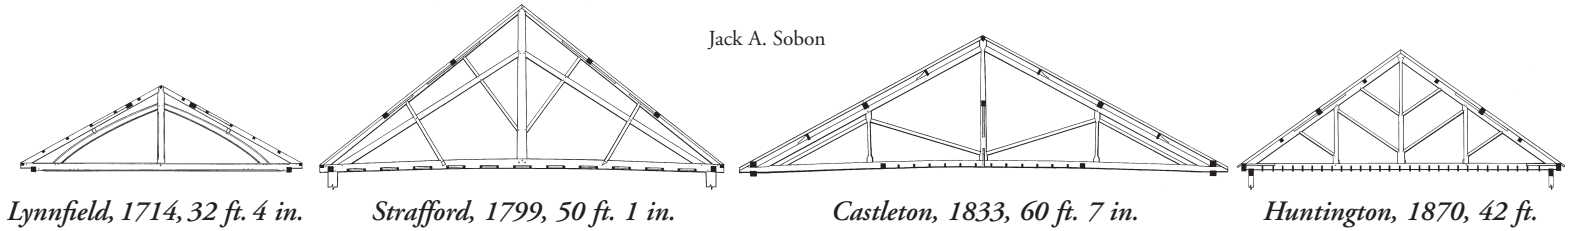
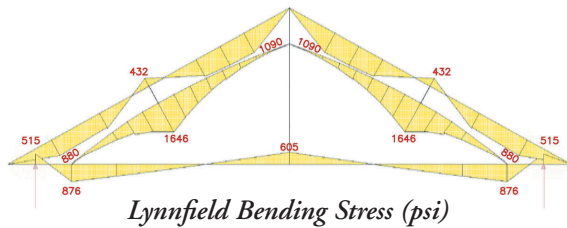
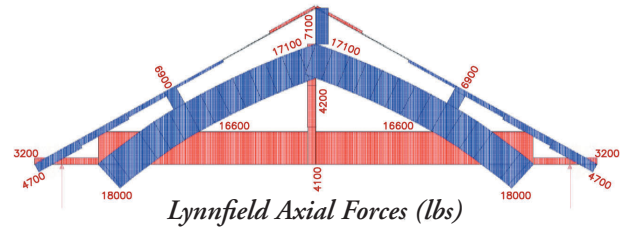
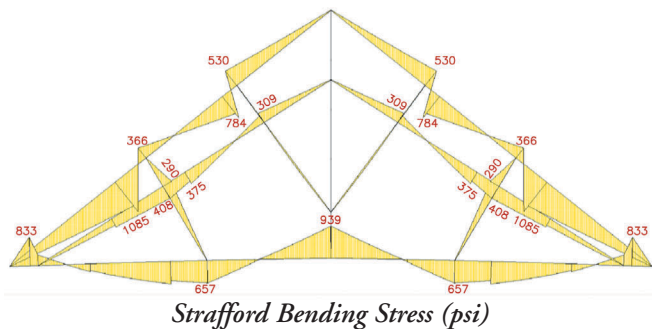
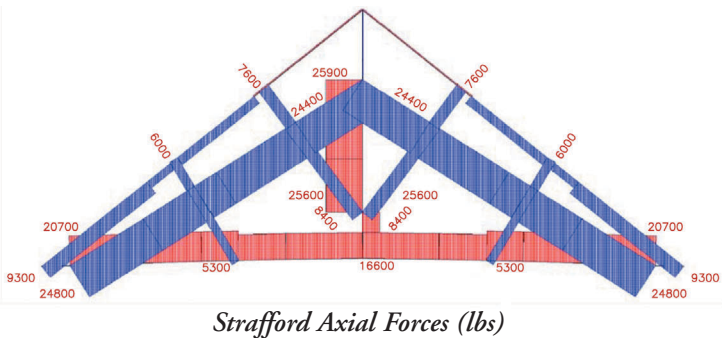
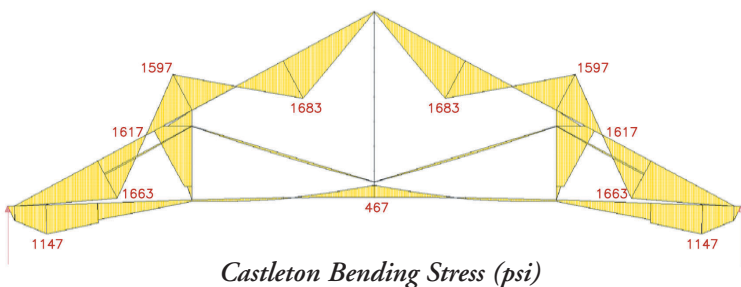
AS with the scissor and queenpost trusses described respectively in TF 69 and 71, the four kingpost roofs described at length in TF 72 were tested virtually via Finite Element Analysis (FEA), subjected to a standard roof live load based on 65 psf ground snow load, plus dead load of ceiling, floor, frame and roof as indicated. The results of these analyses are presented below. In the axial force diagrams printed on the facing page, compression is indicated by blue, tension by red.
